building OPERATING management

Preventing Human Error

Addressing the biggest source of downtime risk takes disciplined follow-through by alan hart and david boston

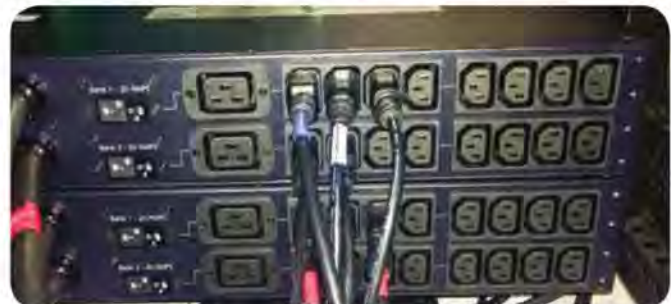
Red tape identifies the B side of the two cords supplying power to dual-corded devices. No tape is placed on the cord that is fed from the A side. In addition, blue tape is placed on each power feed to a single-corded device.

- F. Verify that the power cords connected to the device have proper redundancy and have the associated color representation.
- ___ 1. Make sure the connections between an automatic transfer switch (ATS) and the IT equipment maintain an "A" and "B" bus configuration in order to ensure redundancy.
 - ___ 2. Make sure all dual corded devices have two power cords.
 - ___ 3. Ensure that the power cord between the IT device and the "A" bus ATS is a black cord.
 - ___ 4. Ensure that the power cord between the IT device and the "B" bus ATS is a black cord with red tape on both ends of the cord.
 - ___ 5. The power cord connections between a single-corded IT device and an ATS must be wrapped with blue tape on both ends of the cord.
